# TISBURY ELEMENTARY SCHOOL

Existing Conditions Report

JANUARY 31, 2020  
REVISED MARCH 6, 2020

TAPPÉ  
ARCHITECTS

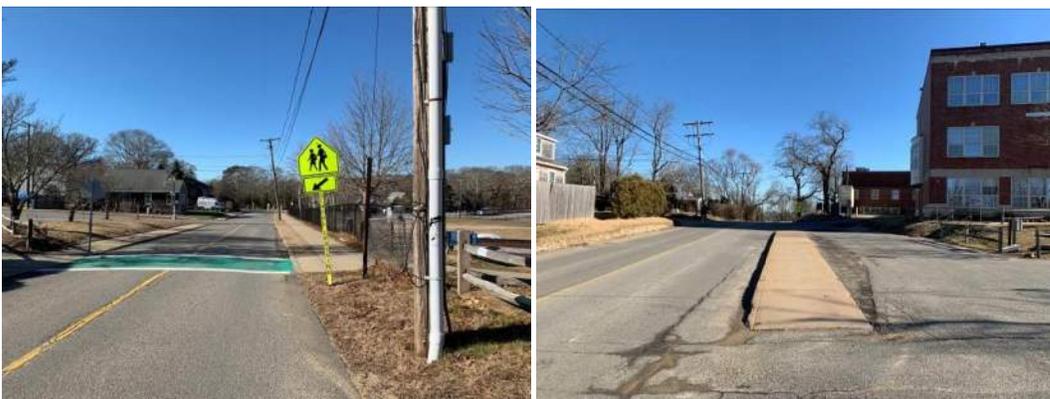
Pedestrian access is provided to the site from surrounding neighborhoods at multiple crosswalks to the sidewalk that exists around most of the school site. There is also a sidewalk on the opposite side of W. William St that leads to the Town Center. Accessible curb ramps do not conform to code. Examples of the sidewalks are shown below:

The sidewalks, driveways, and parking lot are in disrepair in multiple locations and will need repair to address safety hazards and code non-compliance. The building and site stairs and accessible ramps are also in poor condition, several with handrails that do not conform to building code.

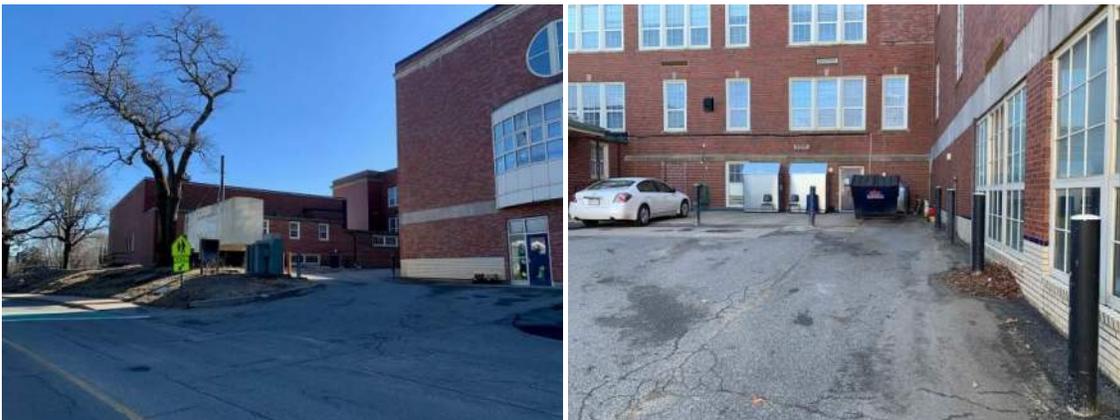
The service area is accessed from Spring Street and appears to include adequate paved space for service vehicles but maneuvering for larger vehicles appears challenging. The asphalt surfacing is cracked and in disrepair.

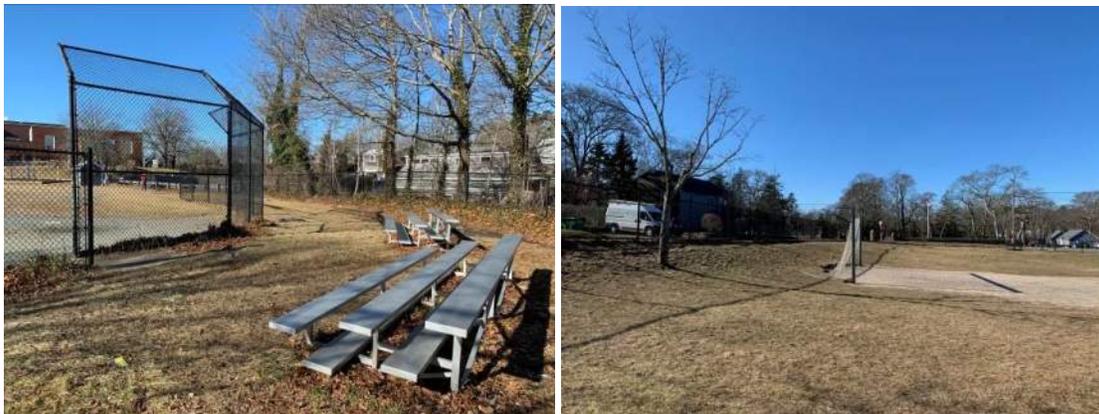
There is a soccer field, a softball field and a half size basketball court. Portable aluminum bleachers provide spectator seating that are in good condition along with the softball backstop and goals for the soccer. A storage shed in the vicinity appears to be in good condition.

The grass playing fields are exhibiting high wear areas with bare, compacted soil. Evidence of ponding water is apparent behind the softball backstop. Lack of irrigation and overuse has resulted in significant bare soil not providing a healthy playing environment as shown below. The basketball courts surfacing is worn with several cracks and needs to be repaired or renovated. The basketball posts and net are in poor condition. The court markings and the painted pavement games markings are worn out.

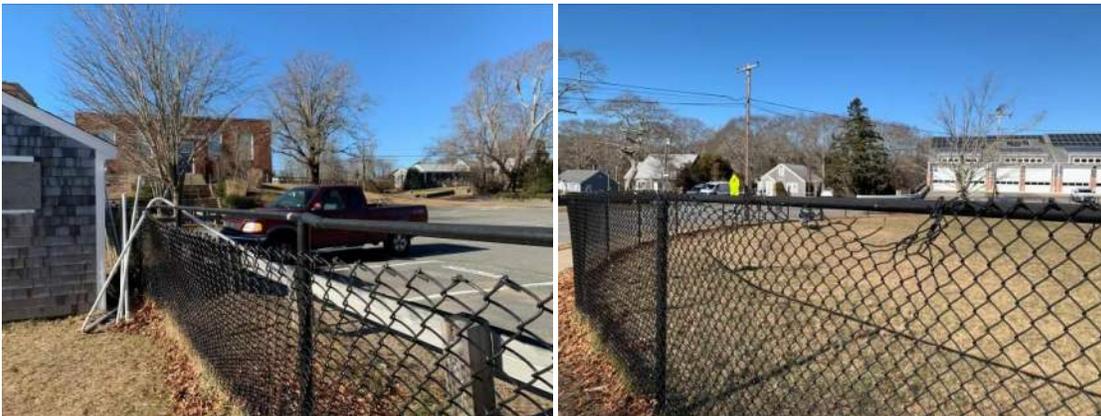
In general, the chain link and split rail fencing around the site is in reasonably good condition, but in few places it is in disrepair as shown below.

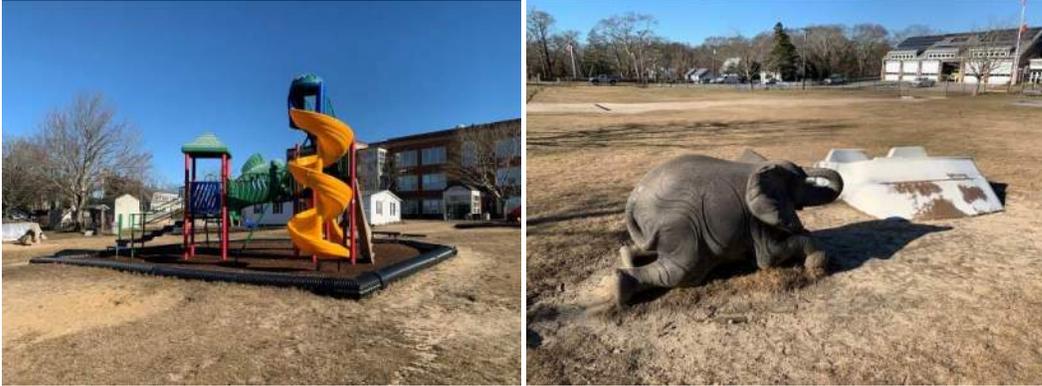
The school playgrounds are in fair to poor condition but lack accessible routes to the equipment. The wooden play structure, part of boat structure, independent concrete animal statues of elephant and camel are interesting and unique creative play elements but are not integrated well in the site landscape. The metal and plastic play structures appear in fair condition but they are outdated in terms for providing play variety. The surfacing is wood chips and likely does not meet safety impact attenuation standards and ADA standards.

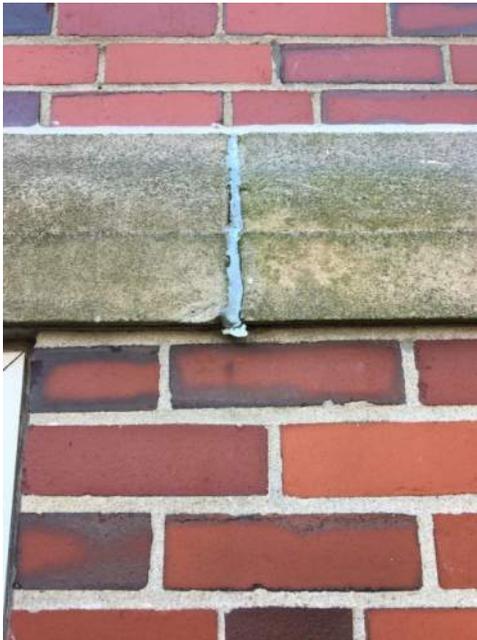
The exterior wall construction of the building consists of masonry brick bearing walls, which are assumed to be three wythes of brick, with no air cavity space. The masonry walls are in fair to poor condition around the building and need considerable repairs. Numerous cracks appear at locations around the perimeter, along with signs of water infiltration. It appears that an attempt was made to repair the cracks, but was done with sealant. The sealant has now also failed at these locations. A proper repair with mortar is required to prevent further water infiltration.

Failing sealant repair at cast stone

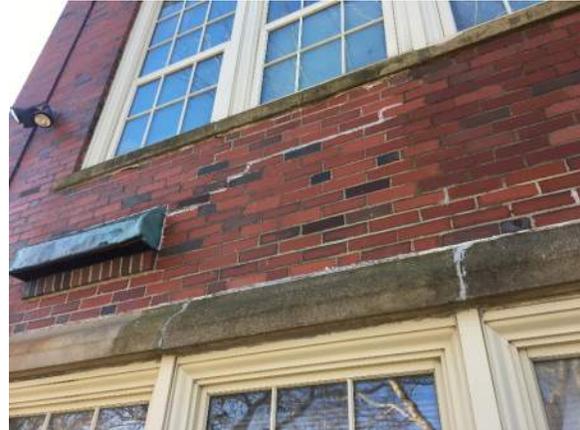
Sealant repairs at brick and cast stone

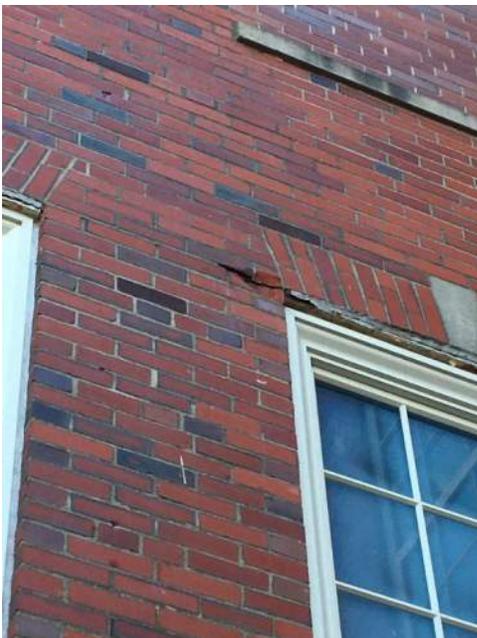
The majority of the bricks appears to be in good condition, but there are a few locations where bricks are damaged, cracked, or spalling. All cracked and damaged bricks should be replaced to prevent additional water infiltration into the walls. Cleaning of the brick is also recommended, and should be done so in a manner that does not drive more moisture into the walls. Future testing should be done on the walls and brick for water and air infiltration. This will be required in order to determine how the walls can be insulated in a manner to not trap moisture within the walls, and cause further deterioration.

Damaged bricks adjacent window head

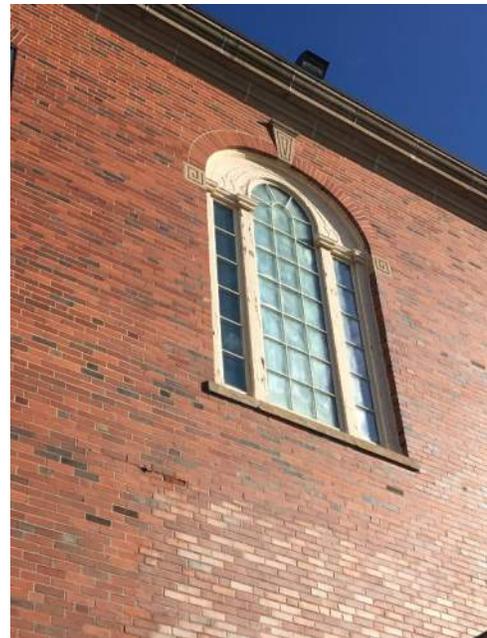
Damaged bricks

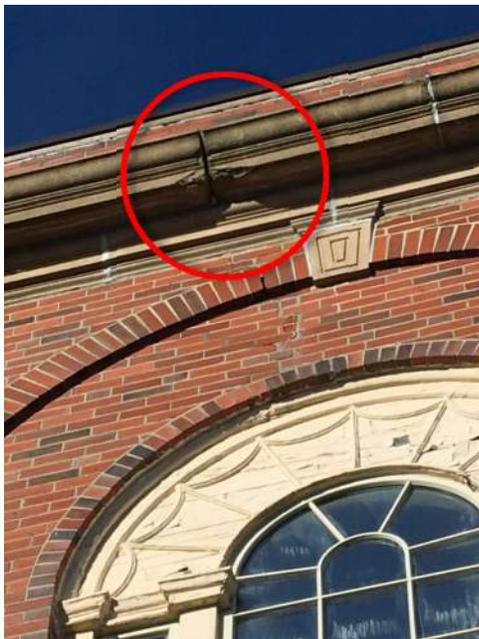
Decorative cast stone elements are also part of the façade. Cast stone sills are located below all of the windows, along with a cast stone band that wraps the building at the head of the first floor windows. A cast stone cornice wraps the building, with an entablature on the South façade above the main entry that reads "Tisbury School." The brick continues up above the cast stone cornice to the roof / parapet. A cast stone cap tops the walls, which is partial cover by a metal roof edge. The cast stone sills are cracked, chipped and spalling along with pieces of the cornice. Mortar joints between the pieces have failed at both the sills, banding, and cornice. Again it appears that repairs were done with sealant rather than grout, and the sealant has failed. Restoration and replacement of the decorative cast stone is necessary, along with the repointing of all vertical joints.

Damaged cast stone cornice

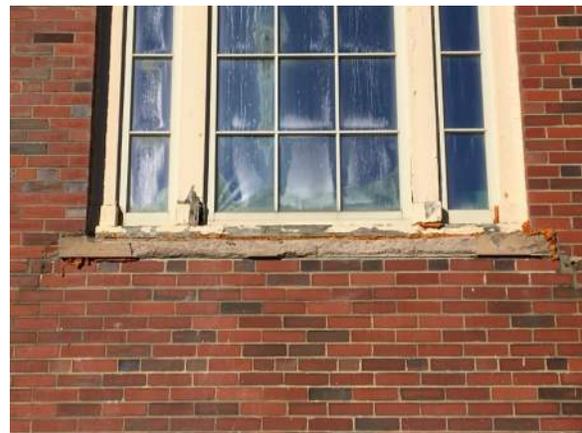
Deteriorated sill that needs replacement

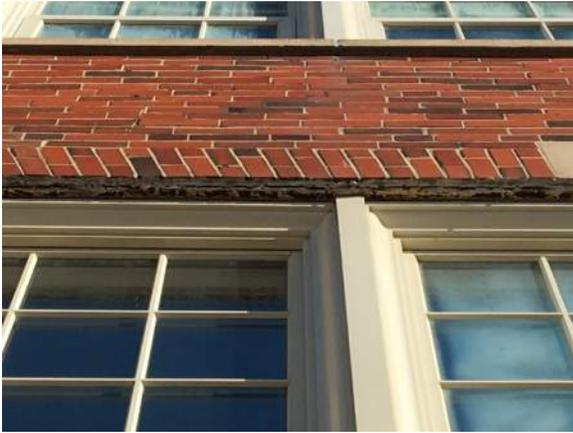
The steel lintels at the heads of the windows and doors display signs of distress. Peeling paint and major corrosion are clearly seen on the majority of the steel lintels around the building. Sagging of the lintels can be seen at the cast stone banding at the heads of the first floor windows. Gaps can be seen between the top of the lintels and bottom of the brick above. This is another sign of the lintels beginning to sag, which will lead to further damage to the brick masonry walls. Sealant was installed along this horizontal gap between the lintel and brick, likely as a repair to try and prevent further water penetration into the building. This could cause water that is already in the wall, back towards the interior of the building, since it no longer has a path out. Replacement of existing lintels with new galvanized steel lintels is recommended.

Oxidized steel lintel at window head

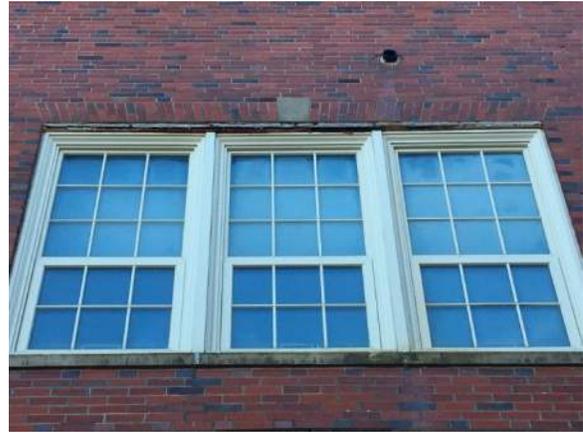
Sagging steel lintel with sealant repair

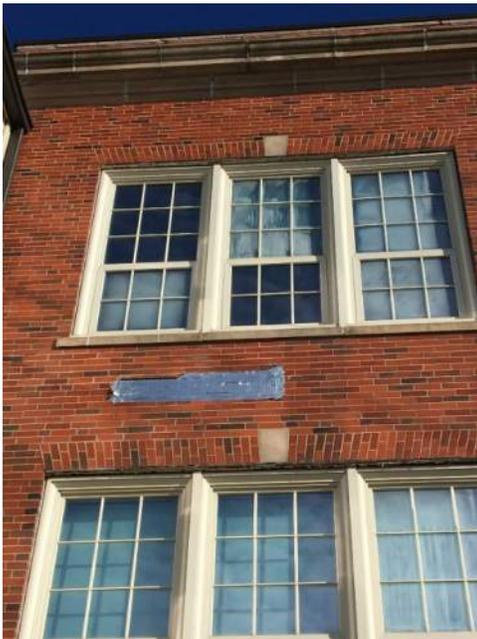
Some of the outside air intake louvers in these walls have been blocked off or covered with tape. This was likely done to prevent air infiltration back into the building from units or dampers that have failed.

Covered mechanical louver

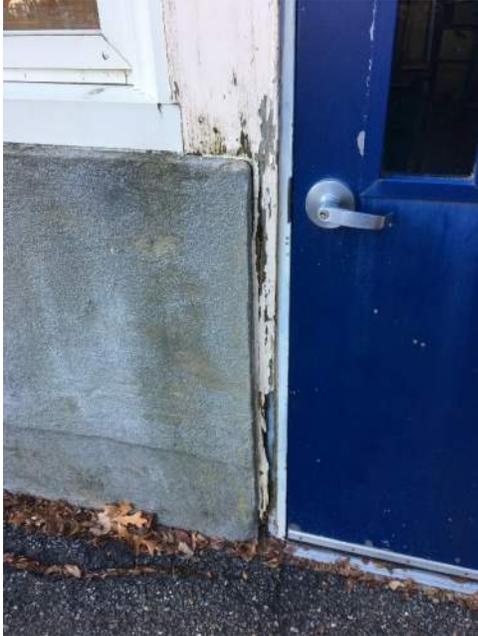
All exterior wood trim and decorative elements on the façade need to be restored and repainted or replaced. Chipping paint and disrepair are apparent around the building.

Peeling paint at wood trim

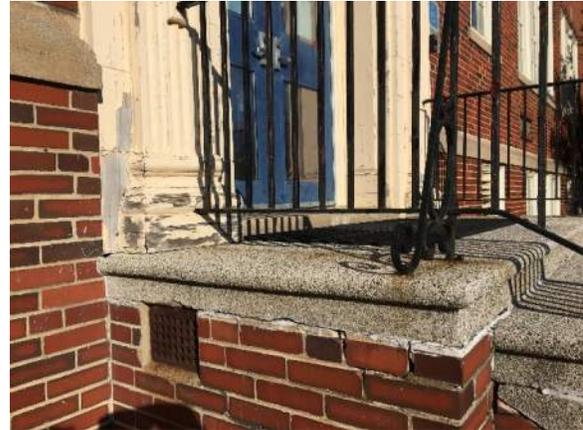
Damage wood and flaking paint at main entry

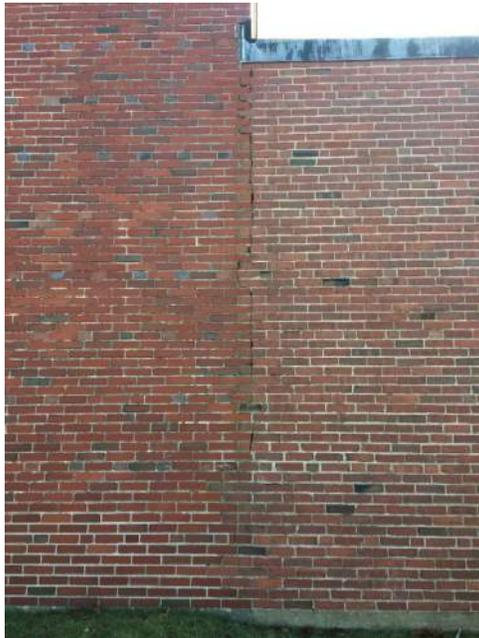
Gym - Crack due to lack of control joint.

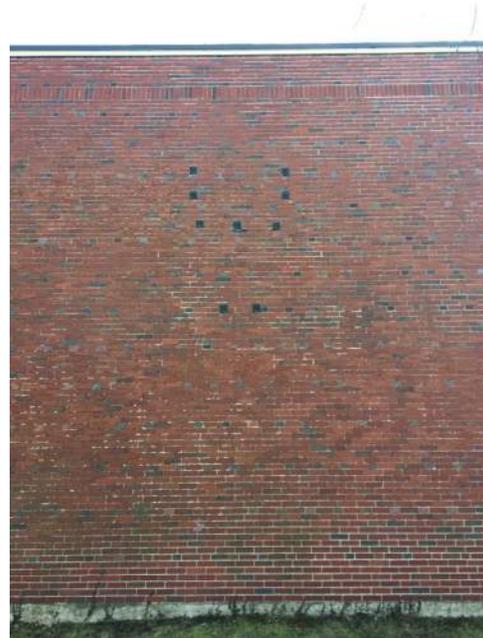
Gym - Through wall steel fasteners.

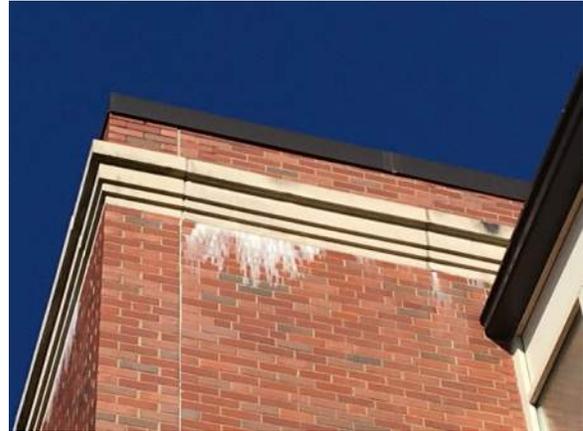
Efflorescence adjacent to kindergarten entrance.

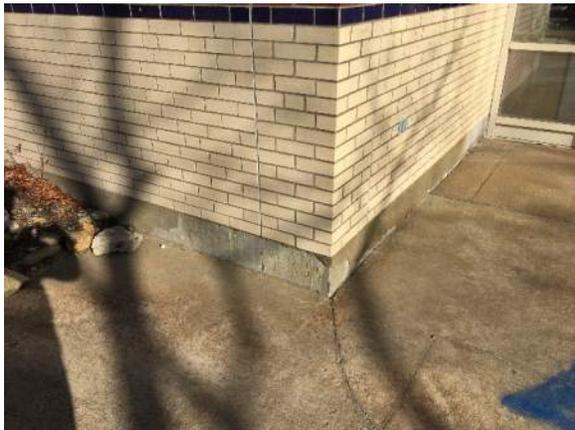
On the North and West facades, portions of the concrete foundation wall are visible below the brick. The concrete parge coat that was applied over the exposed foundation has deteriorated, and has cracked or missing all together in multiple locations. The masonry veneer on the North façade rests on a steel angle rather than directly on the concrete foundation. The angle is rusting but appears to be structurally sound. It should be prepped, primed and painted to mitigate potential future deterioration.

Failing foundation parge coat on West façade.

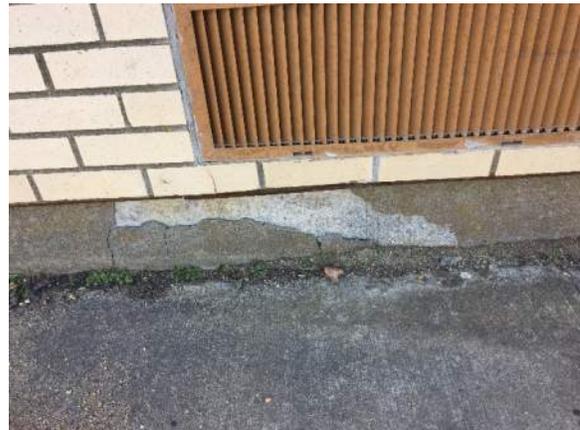
Failing foundation parge coat on North façade and rusted steel angle supporting the brick.

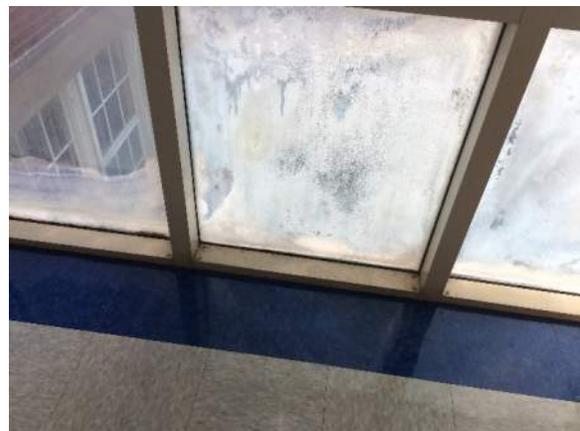
Fogging of glazing panels with failed seals

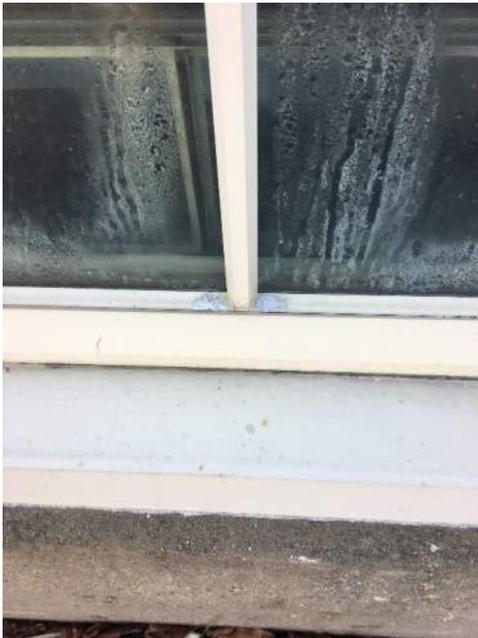
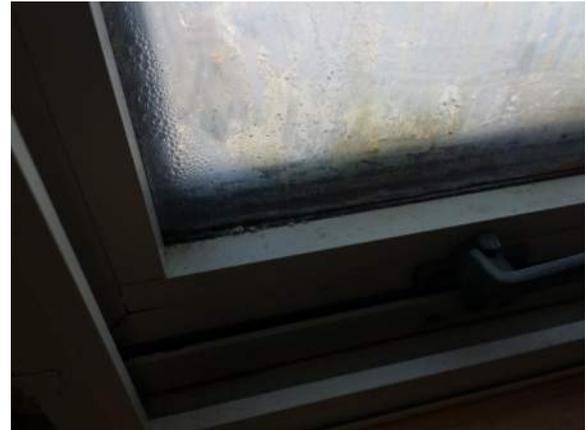
Moisture and fogging inside glazing panels

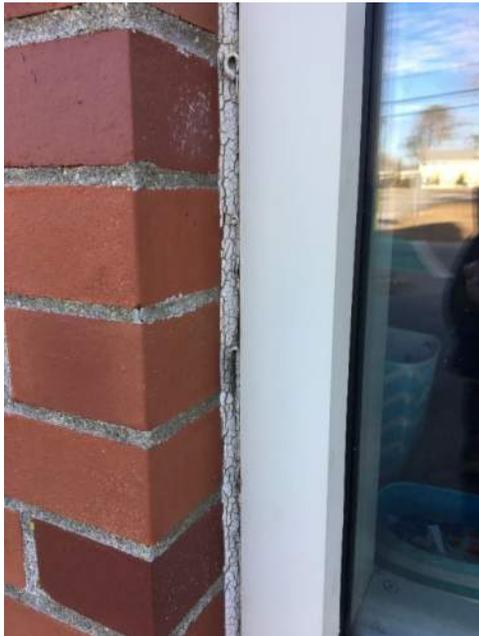
The sealant around the perimeter of the windows and curtainwall is showing its age. It no longer has its flexibility, and will continue to harden and get brittle. This weakens its resistance to maintain a weather tight seal, and may be the reason for the window leaks that are occurring. There were a few locations where the sealant was seen hanging out of the joint at the head of the windows.

Non-flexible and deteriorating sealant

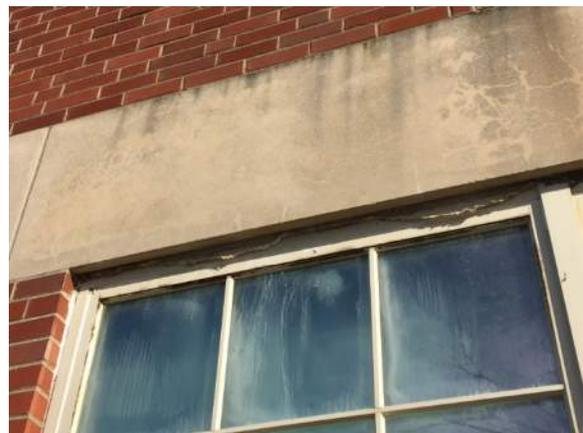
Sagging sealant at window head

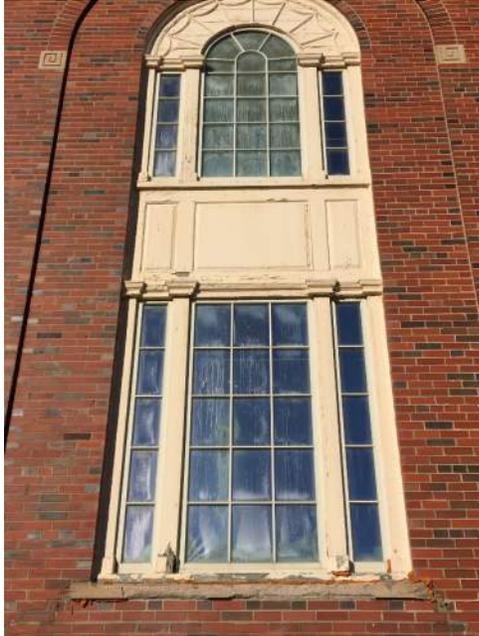
Painted decorative wood surrounds occur at a few windows on the 1929 building. The paint is chipping and peeling, and the wood is deteriorating. There are locations where holes and rotting were evident, or the pieces are completely missing. Extensive repair and restoration is required.

Decorative wood window surround

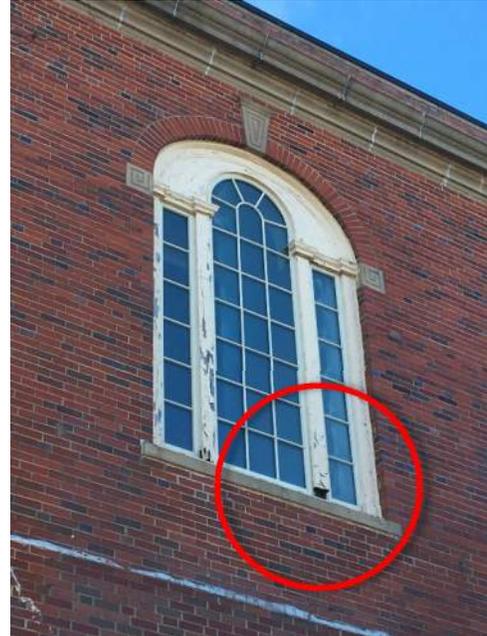
Missing wood plinth block

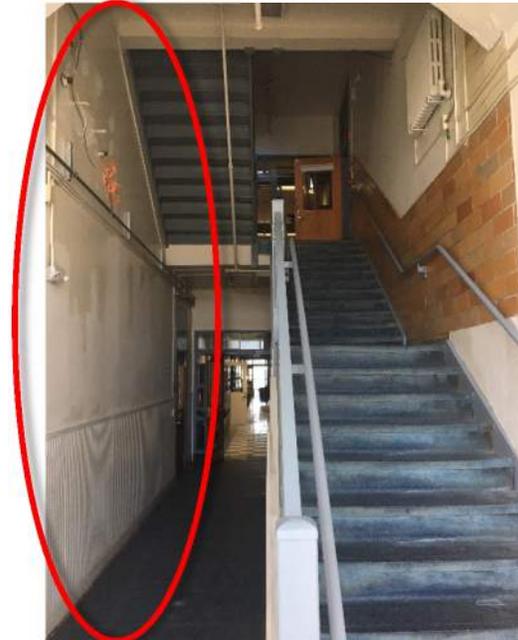
Damaged / patched plaster walls in stair

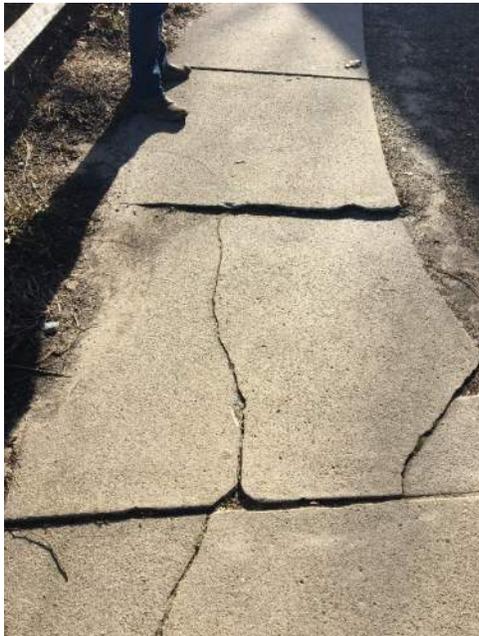
The building is located at the high point of the site, with the topography sloping away from the building. These elevation changes primarily only have stairs provide to traverse them. Accessible routes are not provided to all the building entrances or public spaces around the site. The existing stairs, walkways, and ramps all need to be brought up to the current standards, including the guardrail / handrail assemblies. Sidewalks around the building have deteriorated, with significant cracking, chipping and buckling. The lower parking lot on the East does not have an accessible route to or from the building. Similar issues occur at the playgrounds, and bus drop-off area. On the south side of the building, parent drop-off occurs at the semicircular drive off of West William Street. The main entrance is located here, but is not handicapped accessible since access up a flight of stairs is required.

Deteriorating and buckling walkways

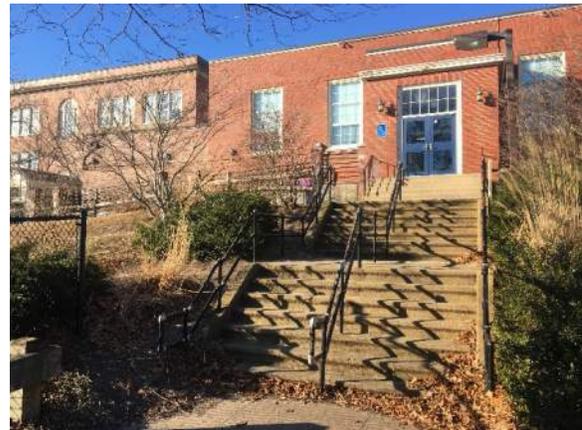
Non-accessible route from lower parking lot

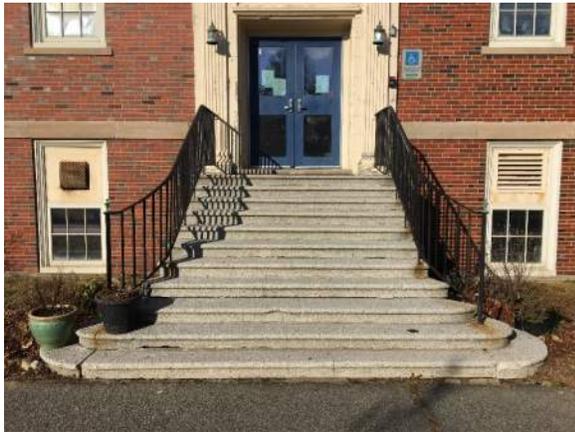
Non-compliant main entry stair

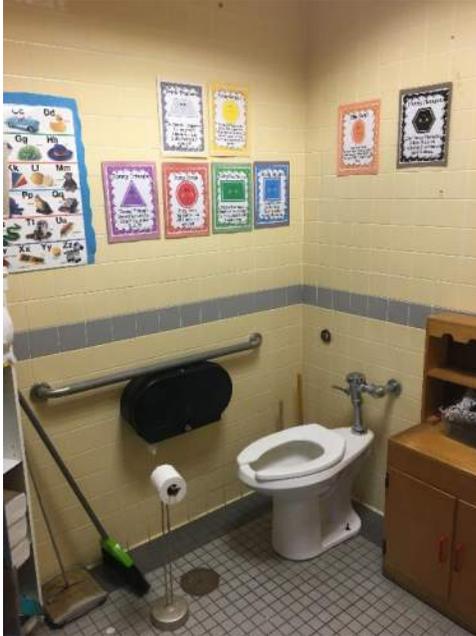
Missing rear grab bar - kindergarten

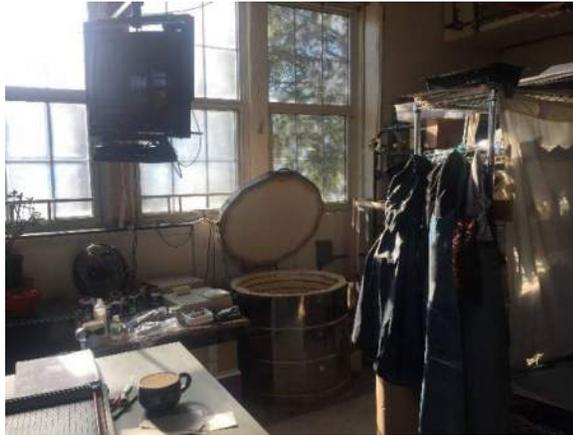
**KILN W/O EXHAUST**
