# TISBURY ELEMENTARY SCHOOL

Existing Conditions Report

JANUARY 31, 2020  
REVISED MARCH 6, 2020

TAPPÉ  
ARCHITECTS

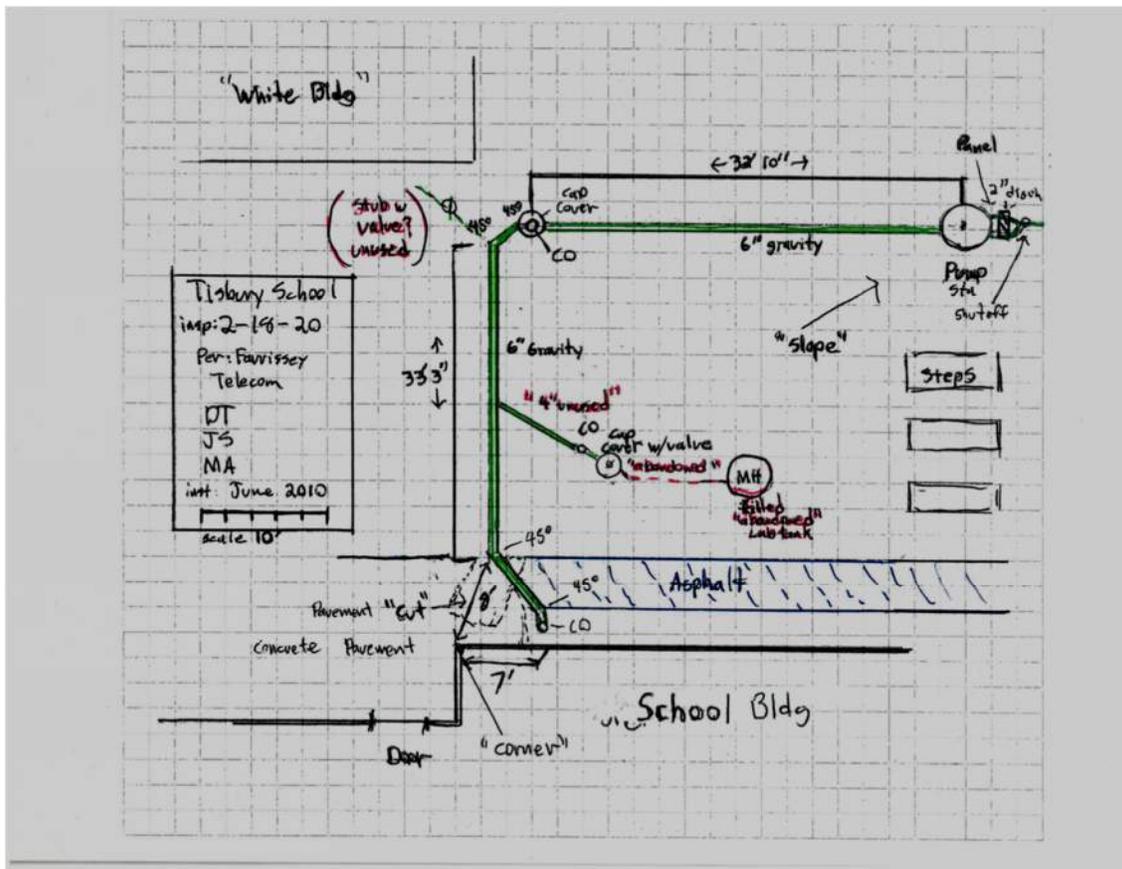
**SEWER CONNECTION**

Nitsch Engineering understands that there is a sanitary sewer connection from the Elementary School to the sewer pump station located on the site near Spring Street that is then connected to the Town's Sewer System. Nitsch Engineering understands that this work was performed by the Town. The project team received the sketch below from the Tisbury DPW that shows the layout of this sewer piping connection.

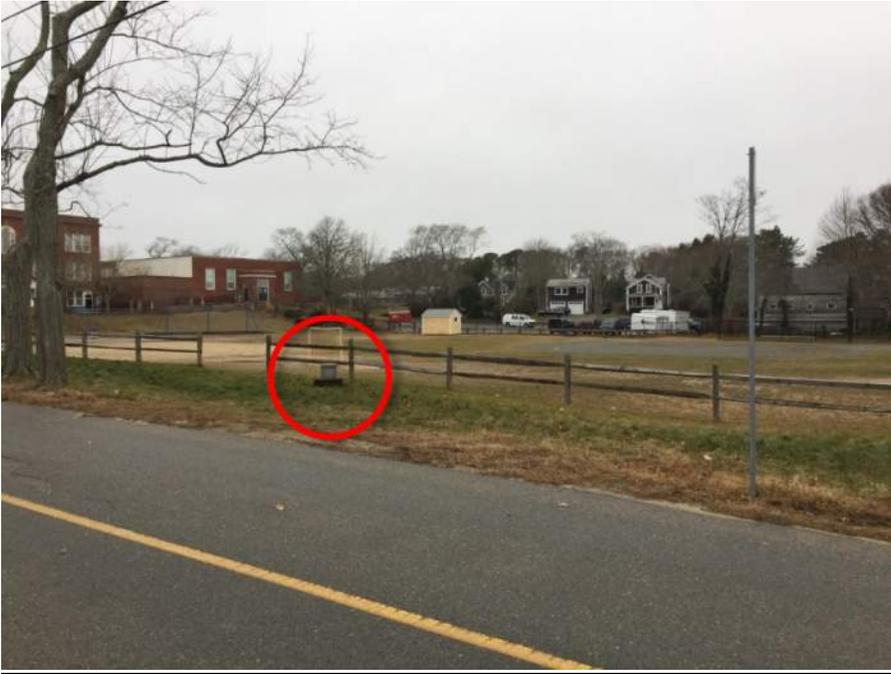
**SEPTIC WICK #1**

There are two (2) effluent disposal wicks located on the school property off William Street. According to a report entitled, "Tisbury Effluent Disposal Engineering Report in support of Groundwater Discharge Permit Application for the Department of Public Works, Tisbury, Massachusetts" dated August 2015, prepared by Wright-Pierce, the 24-inch diameter wicks were installed in 2013. The report mentions that "An effluent disposal wick is a vertical subsurface structure built for the purpose of transporting highly treated effluent to the groundwater. A wick is basically a large diameter borehole that can be partially or completely filled with gravel pack. The entire top of the wick can be enclosed in a precast concrete structure to protect it from the elements and vandalism. This type of system has a low profile, utilizes a small footprint, and fits well within the Elementary School site." Each wick is connected to a 4-inch force main that connects to a Wick Flow Distribution Structure (8'x16') located between the wicks. There is a 6-inch sewer force main from the Wastewater Treatment Facility (extension from Pine Tree Road) to the structure. The wicks are not in service at this time. There will be restrictions on construction activity around the wicks to avoid damage to them.

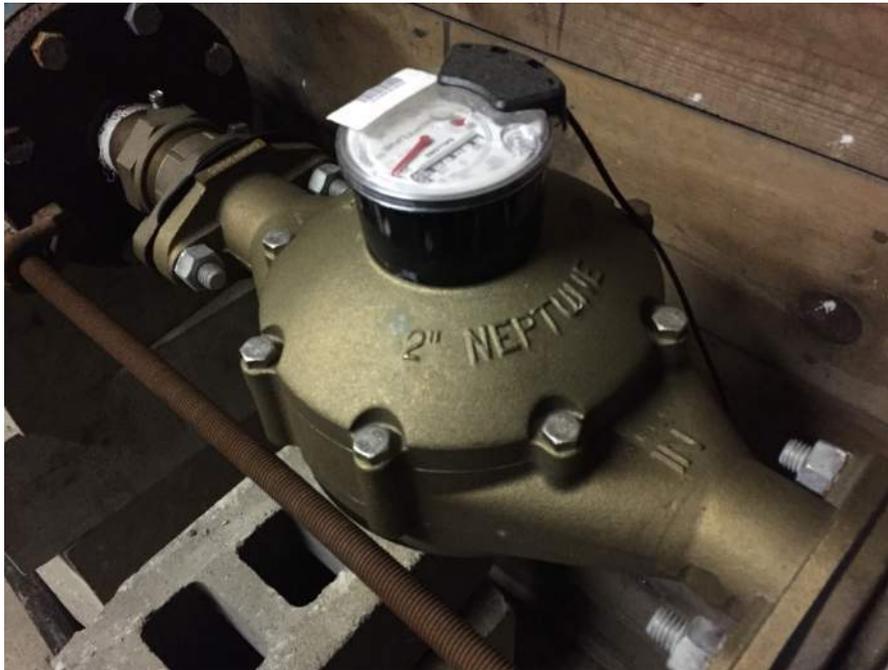
**2-INCH WATER METER IN BOILER ROOM**

The domestic water service appears to be connected to a 2-inch water meter (No. 0060849005) located in the boiler room.

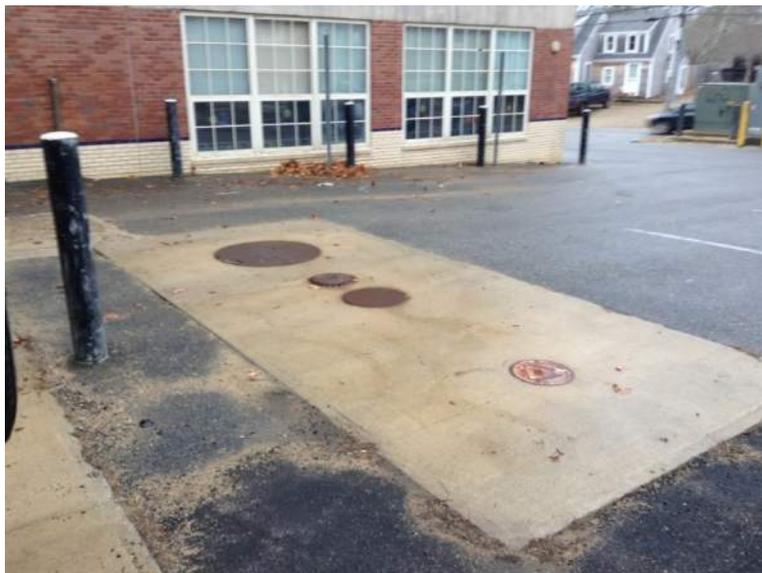
**BELOW GRADE TANK AND MONITORING WELL**

Two (2) tanks, a below grade tank of an unknown size and a smaller above ground tank was observed behind the school.

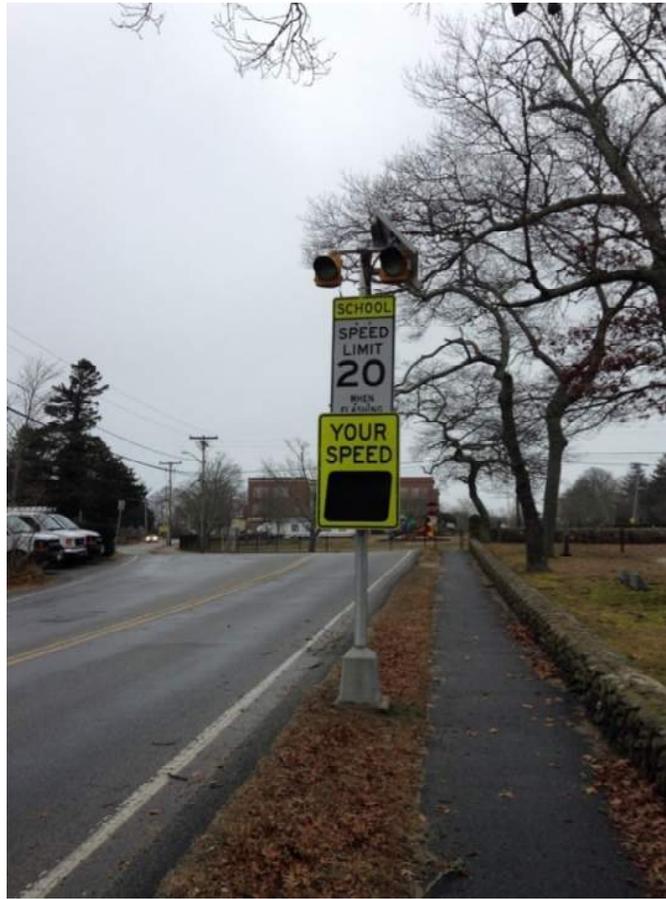
**FLASHING SCHOOL ZONE SIGN ON WEST SPRING STREET**

A solar powered flashing school zone sign was observed on each of the approaching streets (William Street, Spring Street, West Spring Street, Martin Street, Pine Street and Pine Tree Road) to the Tisbury Elementary School.

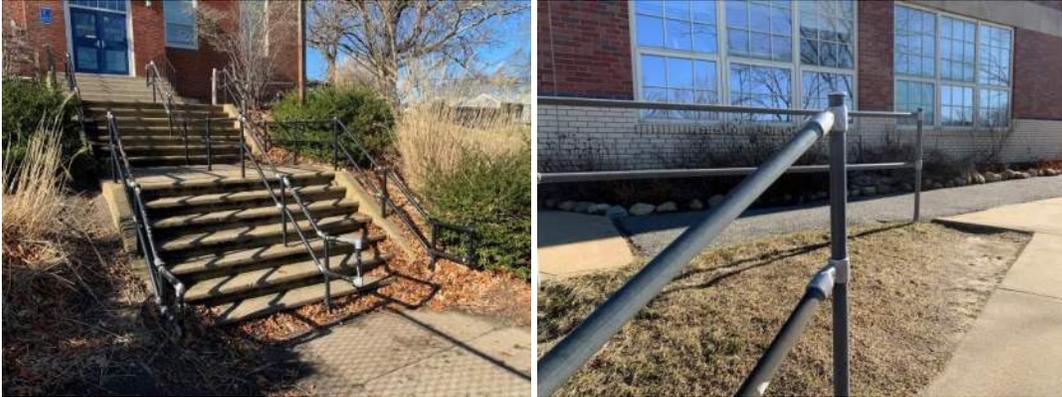
The sidewalks, driveways, and parking lot are in disrepair in multiple locations and will need repair to address safety hazards and code non-compliance. The building and site stairs and accessible ramps are also in poor condition, several with handrails that do not conform to building code.

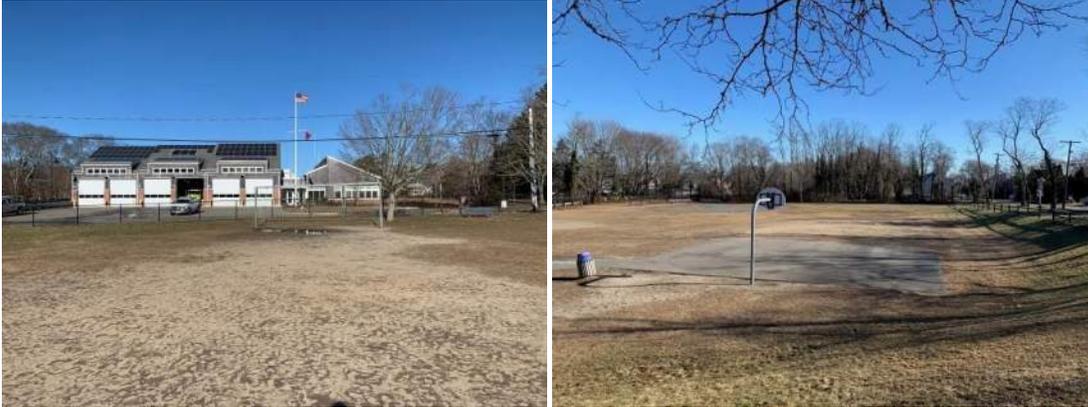
The grass playing fields are exhibiting high wear areas with bare, compacted soil. Evidence of ponding water is apparent behind the softball backstop. Lack of irrigation and overuse has resulted in significant bare soil not providing a healthy playing environment as shown below. The basketball courts surfacing is worn with several cracks and needs to be repaired or renovated. The basketball posts and net are in poor condition. The court markings and the painted pavement games markings are worn out.

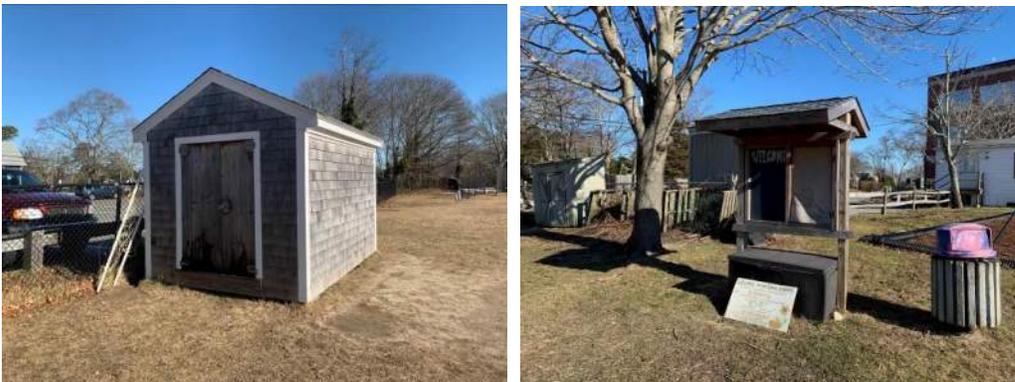
A separate wood frame building known as “The Little White House” is located to the west of the main school building. In addition to the “Little White House”, other structures include storage sheds in the north parking lot by the softball field on the east and another storage shed by the school garden on east side. There is also a storage shed on the north west parking lot, soccer field and couple of garden sheds. The sheds appear to be in fair to good condition but may need some minor repairs.

Additional or replacement fencing should be provided to separate pedestrian and athletic fields and playgrounds from vehicular areas. There is a lot of wooden split rail fencing around the perimeter of the school which looks contextual with the surroundings and also appears to be in fair to good condition.

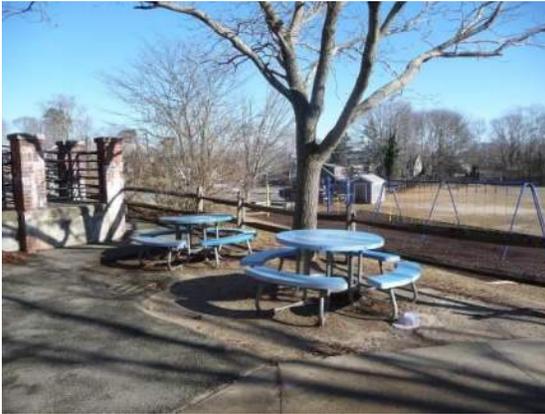
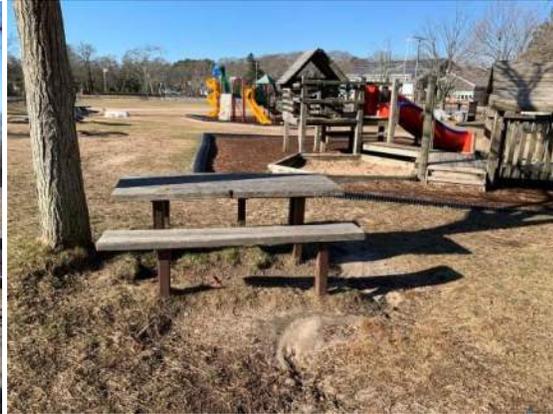
For the school population, there is very little outdoor seating overall. Most the site furniture is metal with some wooden benches with all in varying conditions from new to complete disrepair. Most of the site furnishings lack accessible paths and picnic tables do not provide accessible seating. The trash

barrels and bike racks are deteriorated. All of the site furnishings do not appear cohesive aesthetically. There are 2 outdoor water fountains but were not functional at time of observation.

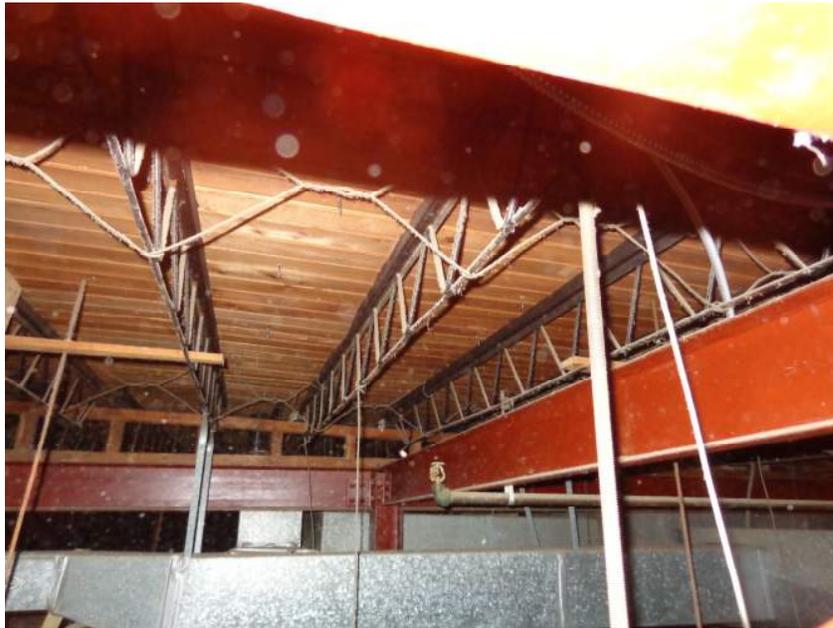
**Roof framing of original 1929 Building**

The existing school structure appears to be performing adequately. The exterior masonry walls of the original structure are in poor condition. The roof framing of the original structure would require stabilization and possible reinforcement. The existing masonry wall connections, if they exist, may require reinforcement. The exterior stairs may have to be replaced or repaired.

Any proposed renovations and additions would likely require that the structure be updated to meet the requirements for the code for new construction. This may require addition of some shear walls, connecting the floor and roof diaphragms to the existing masonry walls and the clipping of non-structural masonry walls to the structure. All of the existing masonry walls would have to be adequately connected to the roof and floor structure.

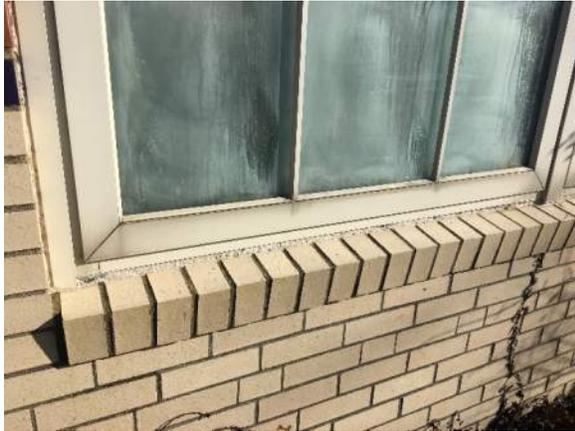
The windows sills are brick and sloped to drain. A precast concrete band wraps the addition at the head of the first floor windows. Toward the top of the wall, there is a precast concrete trim piece / cornice, with brick continuing above up to the roof. Efflorescence is visible at multiple locations below this cornice piece. A metal roof edge caps the wall assembly at the top.

Typical sloped brick sills at classroom addition.

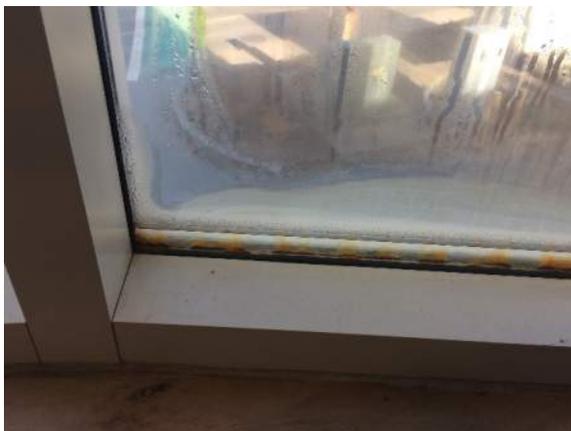
The majority of the glass seals have failed in the windows, which is evident from both the interior and exterior of the building. With the seals broken, the insulating value has been compromised, and condensation and fogging of the glazing units has occurred. Similar failure has also occurred in the aluminum curtainwall. Condensation, fogging, and even oxidization was witnessed inside some of these glazing units. Hardware is failing, so some of the operable windows no longer function properly.

Oxidization inside curtainwall glazing panel

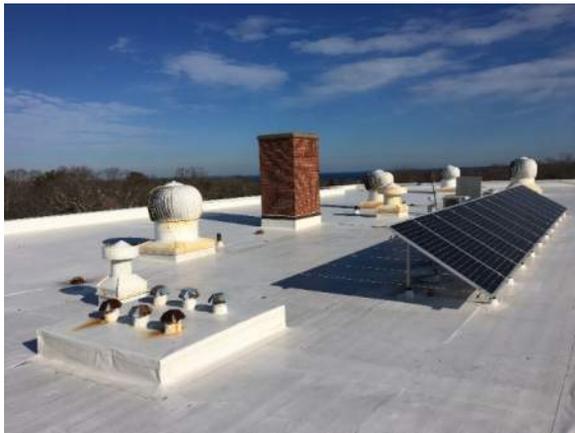
The roof of the 1929 building is a white membrane roof. The principal, John Custer, informed us that the new roofing was installed in 2014, and should still be under warranty. The roof appears to be in relatively good condition, but there are many wrinkles at the underlayment seams. The amount of insulation and R-value was not able to be determined by visual inspection, but likely needs to be increased to meet the current code requirements. The roof is accessible by a ladder and roof hatch located in the janitor's closet on the third floor of the building. A small parapet wraps the perimeter of the original building, but no overflow scuppers or overflow roof drains are provided. A brick chimney extends from the first floor of the building up through the roof. There are some minor cracks visible on the chimney and repointing of the joints would be recommended if it remains. Five large vents on curbs extend up through the roof. They appear to have been repainted at some point, but rusting is still visible. There is a small, twelve panel photovoltaic array, angled to the south.

1929 building - white membrane roof & PV array

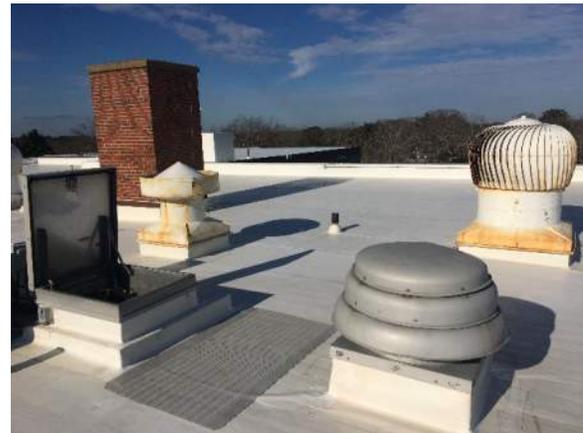
1929 building – roof hatch/vents/brick chimney

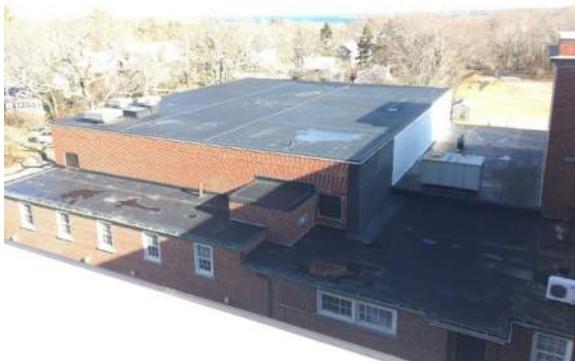
The roof of the gymnasium addition is a black membrane roof and was replaced in 2009, per the PDP report by Turowski 2 Architecture. The lower portion of the roof has gutters along with downspouts around the perimeter. The upper roof at the gym does not have gutters and only has a single roof drain for the entire roof. Additional roof drains would likely need to be added at this location. Minor puddling was visible on all of these roofs during our visit, but nothing that indicated any major issues. The amount of insulation and R-value was not able to be determined by visual inspection, but likely needs to be increased to meet the current code requirements. There is one roof top mechanical unit and a small condensing unit located on the lower portion of the roof.

1938 addition black membrane roof

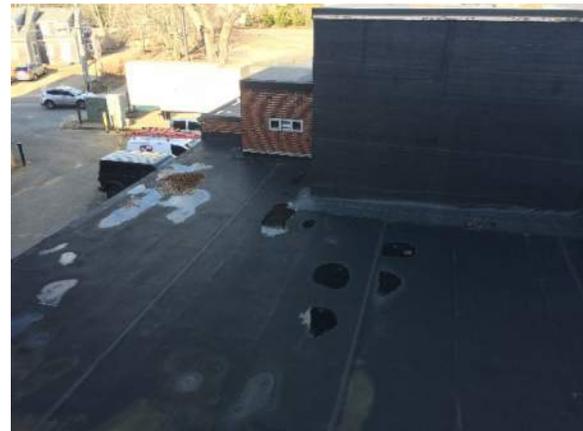
1938 addition - minor roof

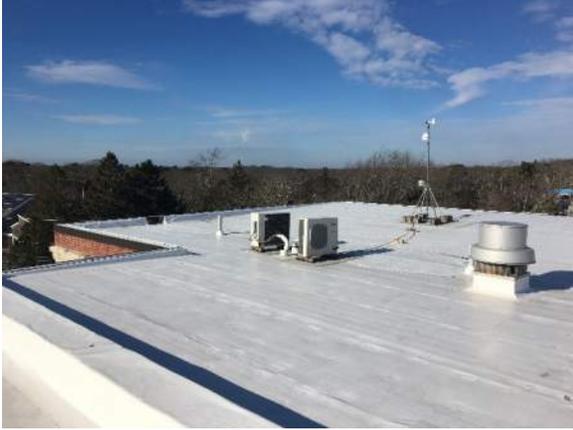
an elevator overrun that extends above the roof level, but is completely covered with roofing membrane. It is unclear if there was an elevator vent that may have been covered over with membrane when the roof was replaced. There is a small weather station that sits directly on the membrane roof that is only held down with CMU blocks. This weather station should be properly anchored to the roof.

1995 addition – white membrane roof, condensing units & weather station

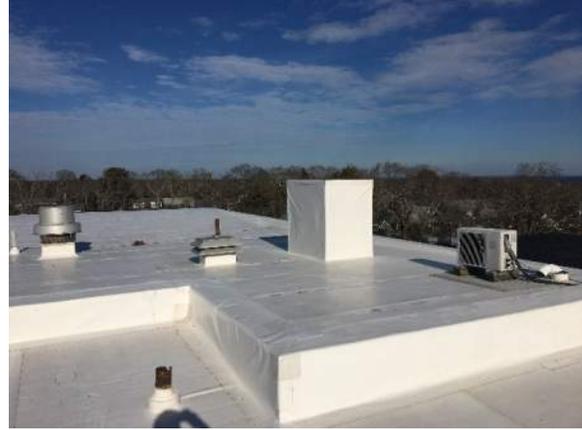
1995 addition – roof curb and elevator overrun

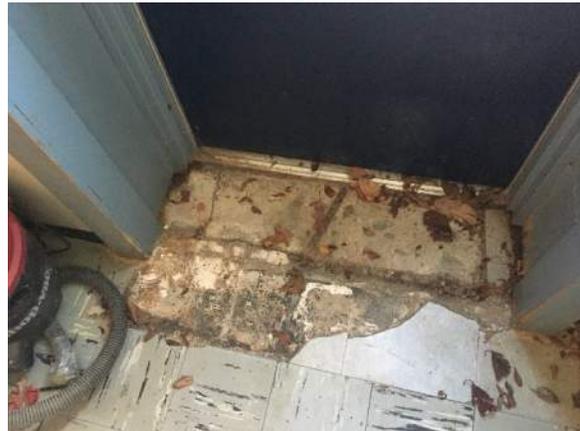
Flooring materials vary throughout this portion of the building. Ceramic tile is found in the main lobby, cafeteria, and toilet rooms. There is a tile mosaic “T” in the main entry stair, outside of the main office. The original wood flooring is still in some classrooms and office spaces. Generally they are in fair condition, but there are locations which are in poor condition due to buckling, and need to be replaced. The wood flooring was already replaced in some of the classrooms with vinyl wood look plank flooring, due to its poor condition. The first floor corridor has VCT, while the second and third floor corridors have carpet. The technology lab has 9”x9” vinyl tile that contain asbestos, and should be properly abated. The tile appears to have been replaced in front of the exterior door, but has failed and the concrete slab below is now visible.

Exposed slab at technology lab doorway.

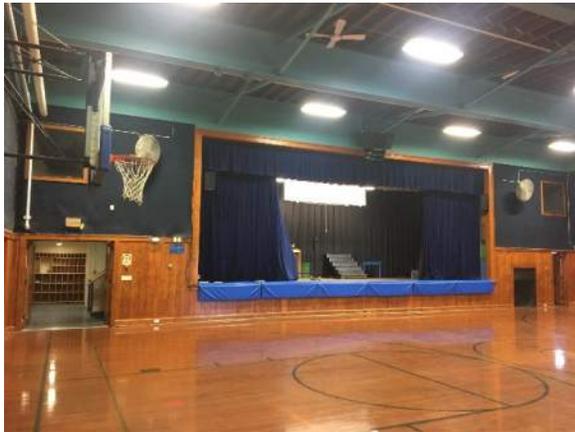
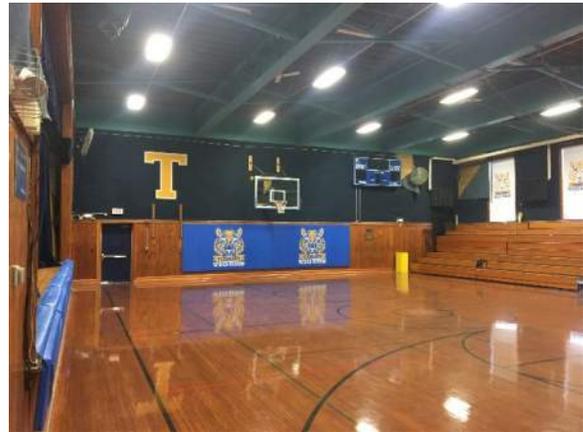
The gymnasium and platform floors are both wood and appear to be from the original 1938 construction. The platform floor is in fair condition, and could use a refinishing. The gym floor is in poor condition due to buckling, unevenness and levelness issues. Students also informed us of “dead spots” in the floor where the ball does not exhibit the same rebound height, as the adjacent floor areas when bounced.

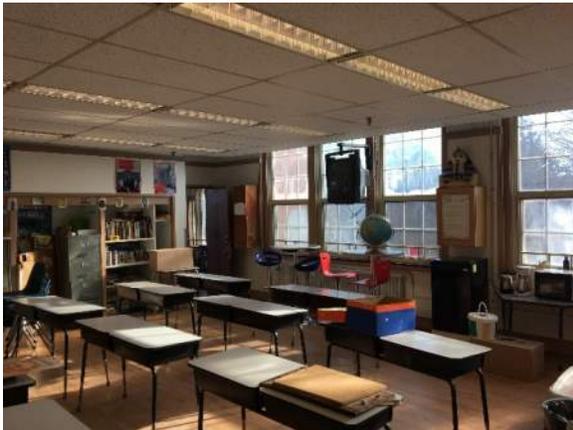
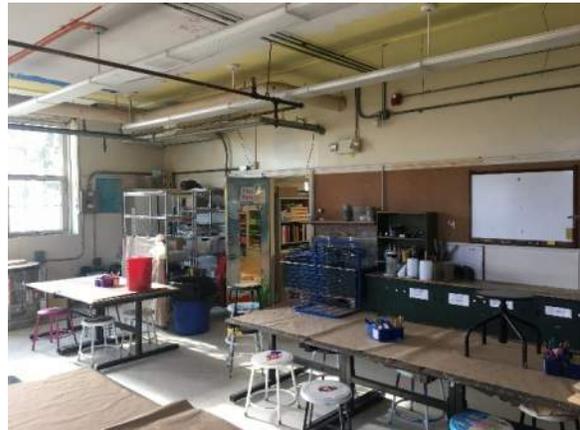
A mix of exposed plaster ceilings and suspended acoustic ceiling tiles are used in this portion building. There is a plaster ceiling in the main entry stair lobby outside of the main office. It appears to be in good condition, but has a few areas where the paint is peeling and chipping. The corridors have ACT ceilings that vary from fair to poor condition. The classrooms ceilings vary, with a mix of exposed plaster and ACT ceilings. The majority of the classrooms have the suspended ACT ceilings with the existing plaster ceiling above. The ceiling height is lower than the heads of the exterior windows, so the ceilings do not run continuous to the walls within the space. These ceilings vary in condition. Some are in poor condition while others are newly installed as part of the recent work that took place to encapsulate the lead paint. Rooms such as Life Skills, Art, and Technology Lab are examples of classrooms spaces that have the exposed plaster ceilings.

If these ceiling are left exposed, they should be patched and repainted.

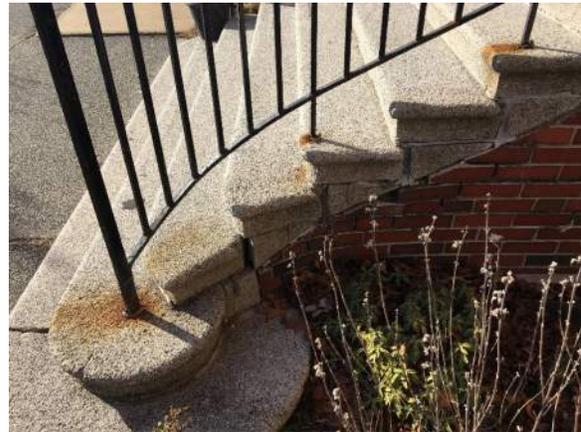
These stairs also do not meet the requirements of 521 CMR 27.00. The stair nosing has a projection greater than the maximum of 1 ½", the wrought iron railing does not have a handrail shape that is round or oval in cross-section, and the railing does not have the required handrail extensions. Cracking is evident on the sides of the stair along the brick, and sealant between the concrete and brick is failing. This could lead to further issues down the road. Another step exists at the double doors into the building, and once inside the building, you need to ascend an additional set of stairs to reach the second floor level. The stair nosing on this stair is also currently non-compliant. Anyone who needs an accessible entrance, needs to proceed to the West side of the building and use the two doorways here that enter into the first floor level.

Main entry stair

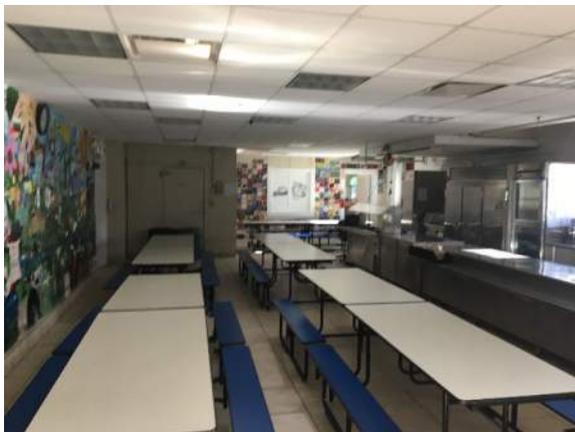
In the cafeteria, accessible seating is not currently provided at any of the tables to meet the 5% required. An accessible route needs to be provided in this space. The aisle access way between tables must be at least 36 inches. There is a floor transition at the door from Life Skills Center to the Cafeteria that appears to not meet the requirements of 521 CMR 29.00.

Lack of accessible aisle and seating

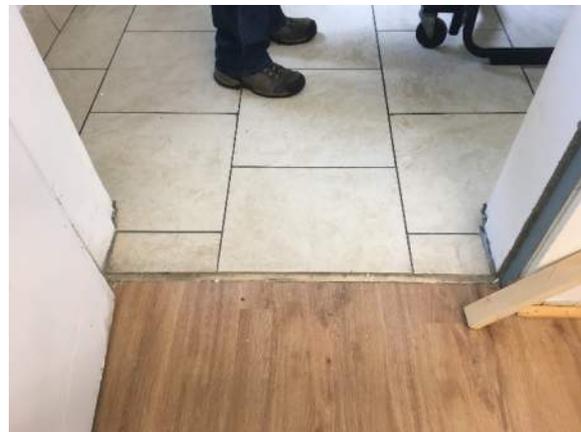
Non-conforming floor transition

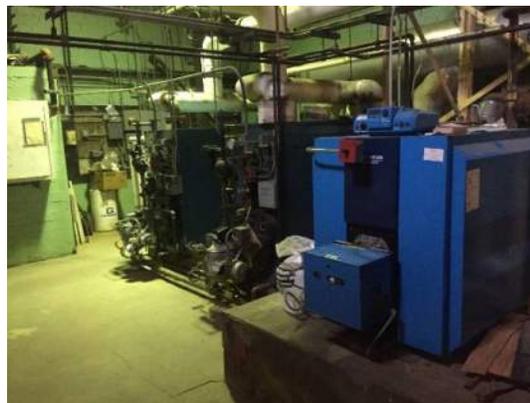
**CENTRAL BOILERS**

The building is heated by (2) two oil-fired cast iron steam boilers and (1) one oil fired cast iron hot water boiler. The single hot water boiler was installed to serve the 1995 addition. The two steam boilers are identical but not the same vintage. The far boiler was installed around 2015 while the middle boiler was installed around 2000. All three boilers appear to be in good working condition. The steam boilers are manufactured by Burnham model V9A with Carlin burners, each having a burning capacity of 13.2 gallons per hour on Number 2 fuel oil. The hot water boiler was manufactured by Buderus Logano model GE315 with a Riello burner having a burning capacity of 3 gallons per hour on Number 2 fuel oil.

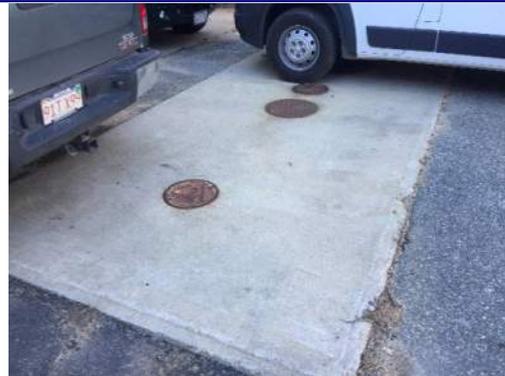
**UNDERGROUND OIL TANK**

Fuel oil transfer pumps are used to feed the three boiler and domestic water heater. The oil tank is below grade located just outside the boiler room. The age and condition of the tank is unknown.

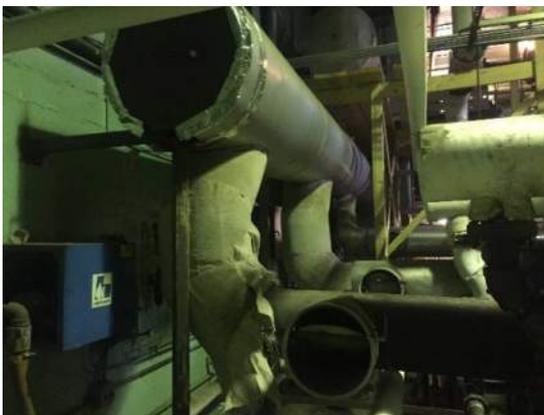
**BREECHING SYSTEM**

Products of combustion are exhausted through a welded black steel breeching system tied into a brick covered chimney. It is unknown if the chimney is lined. If lined the condition of the liner is unknown. The welded black steel is insulated with calcium silicate material with a canvas jacket. Sections of the insulation has been removed to allow the installation of the newer boiler.

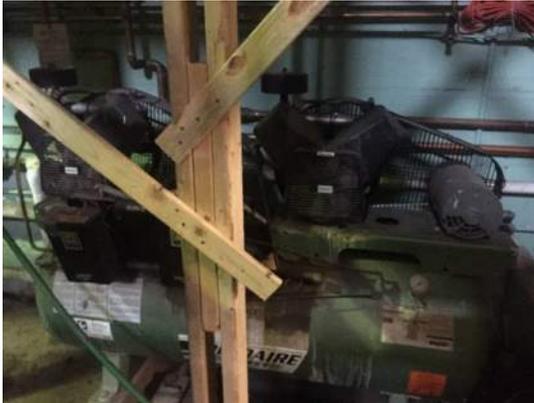
The automatic temperature control system is a combination of pneumatic and electric/electronic controls. There is an 80-gallon air storage tank with two tank mounted compressors, which appears to have been abandon in place. There is no central control system to make global changes, review device trends or trouble

**ABANDON PNEUMATIC CONTROLS  
COMPRESSOR**

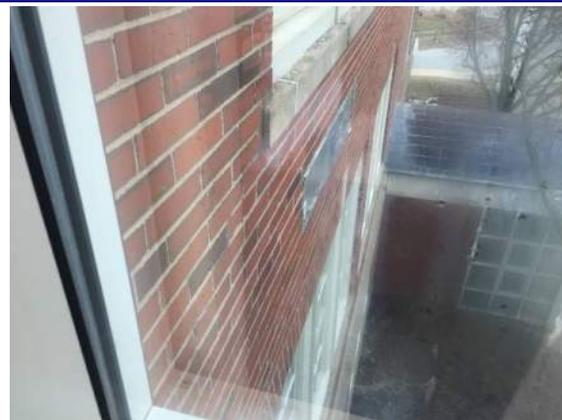
The majority of the building is heated and ventilated by perimeter vertical unit ventilators. Outside air is supplied to the unit ventilators via wall louvers located below the windows. Each unit ventilator either has a steam or a hot water coil, filters, outside/return air dampers and supply fans. Each unit ventilator is controlled by a standalone programmable thermostat. It was noted that the majority of the outside air intake louvers have been blocked off on the outside. This could be due to control issues with the outside air dampers.

**BLOCKED OFF OUTSIDE AIR INTAKES**

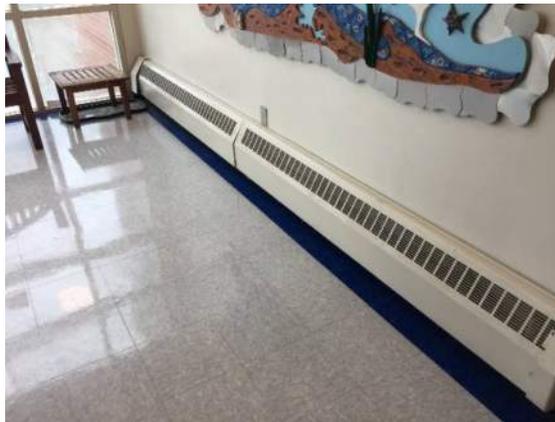
**FIN TUBE RADIATION**

Areas not served by unit ventilators, such as Administration, are heated by either steam or hot water radiation such as fin tube, cabinet unit heaters or radiators. The devices appear to be in fair shape but show signs of wear.

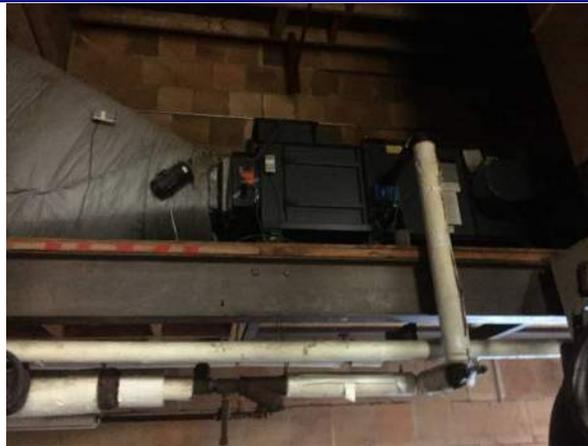
**GYM INDOOR AHU**

The gymnasium is heated and ventilated by two indoor air handling units. The air handling units are located on either side of the stage. Supply air is discharged into the gymnasium by galvanized sheet metal ductwork terminating with mesh side wall grilles. Return air is drawn back through the stage opening. Outside air is ducted to the air handler units from a nearby wall louver. Exhaust air is discharged from the building by wall mounted propeller fans. The gymnasium also has steam radiators mounted mid height on the exterior walls. The gymnasium is also equipped with ceiling propeller fans for de-stratification.

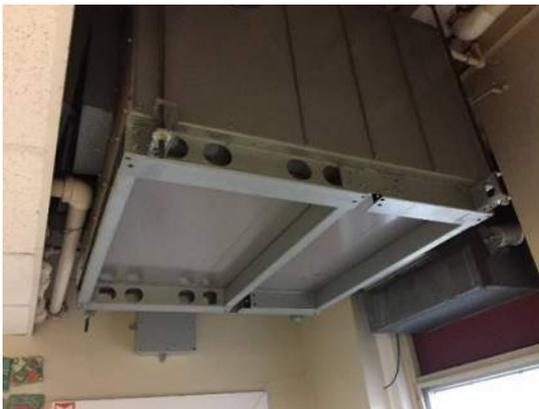
**KITCHEN MAKE UP AIR UNIT**

The kitchen is heated and ventilated by an indoor make-up air unit located within the space. The air handler houses the steam coil, supply fan, mixing box and filters. The unit provides space ventilation as well as make up air to the kitchen hood. The kitchen hood is a stainless steel canopy with a side wall propeller fan mounted at the back of the hood. This design is not code compliant with grease laden air. The hood is not equipped with filters allowing the grease to build up on this hard to clean fan. The dishwasher is not equipped with an exhaust system.

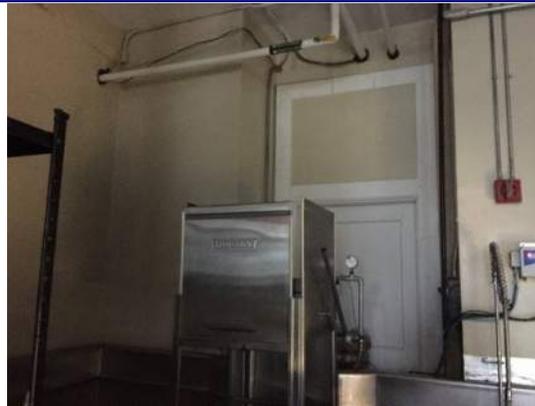
**DISH WASHER W/O EXHAUST**

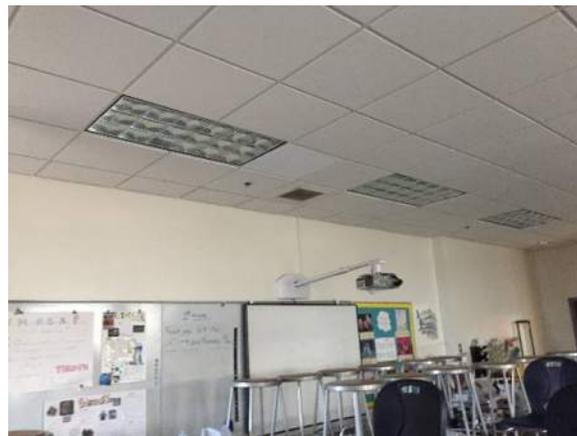
**CEILING CLASSROOM EXHAUST**

Classroom ventilation air is discharged to the space by the classroom unit ventilators. The majority of the outside air intakes to the classroom unit ventilators have been blocked up on the outside preventing outside air from entering the classroom unit ventilators. Classrooms are exhausted though ganged ducted exhaust systems to roof mounted exhaust fans. The exhaust inlets are located low to the floor in the old section of school and at the ceiling in the addition. In some room the exhaust opening has been block over.

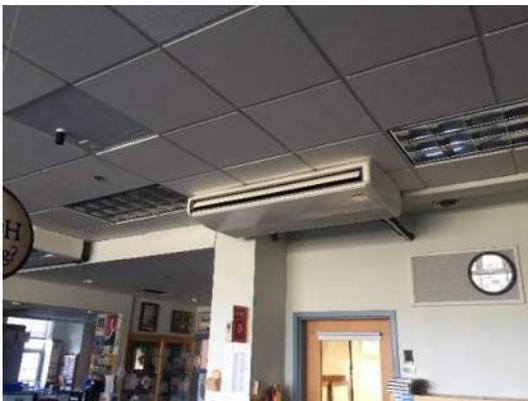
**DUCTLESS FAN COIL (MEDIA CENTER)**

Air conditioning is limited to administration area and media center. Both areas are air conditioned by dedicated ductless fan coil unit with remote outside condensers. The air conditioning units appear to be in good working order. Each ductless fan coil is controlled by a local thermostat.

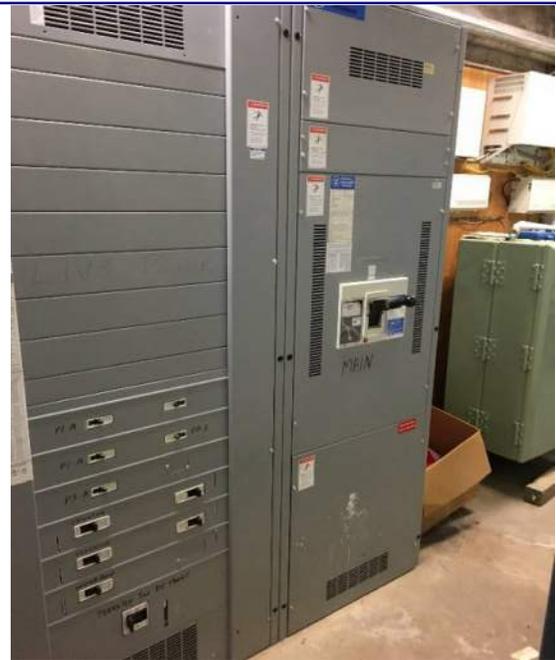
**1600 AMP Switchboard**

Although the switchboard appears to be in good shape it should be tested and cleaned to make sure lugs are properly torqued and breakers are functioning.

The service size should be reviewed at the time of design to verify its adequacy for any expansion / renovation project.

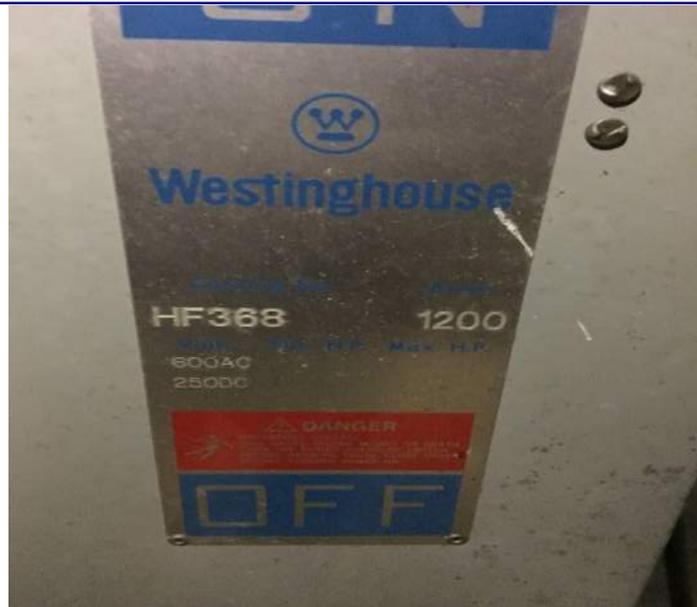
**Fire Pump Switch**

There is a 1200-amp service for the fire pump connected ahead of the main service. The service comes into a 1200-amp switch located in the Fire Pump Room off the Boiler Room. Wiring in the fire pump room is in EMT.

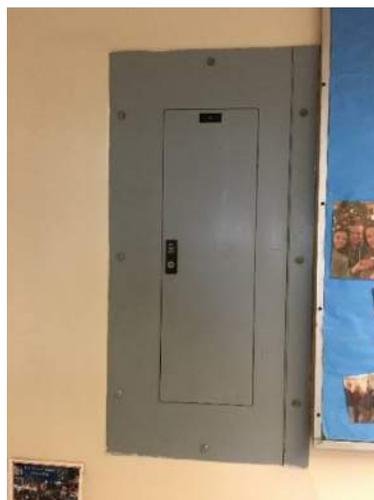
**1997 Wing Panelboard**

Breaker panels are installed on each floor of the building. In the 1995 addition, the panels are flush mounted in the corridor. In the original 1938 building the panels are flush mounted in the corridors and surface mounted in the Janitors Closet. There is a surface mounted panel in the Cafeteria with no emergency off button, as well as a surface panel in the Shop and Home Economics Classrooms. The panelboards in the 1995 addition are in good condition; the panelboards in the 1938 building are in fair to poor condition and should be considered to be replaced during any construction project.

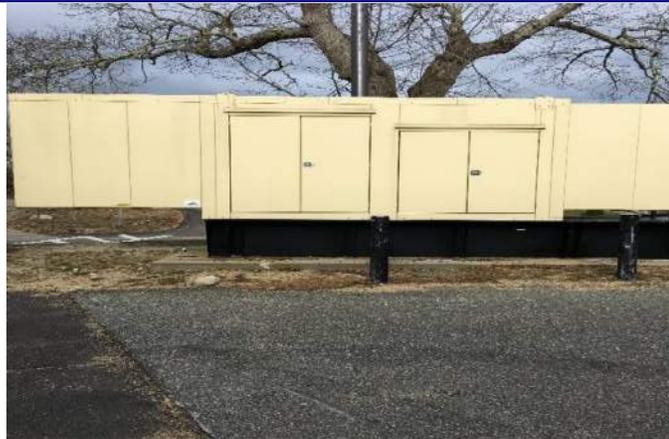
**Emergency Generator**

A building optional standby, backup generator is installed on the exterior, adjacent to the pad mounted transformer. The generator is located in an exterior enclosure with a below enclosure diesel fuel belly storage tank. The generator is rated at 120/208V, 3P, 300 kW and provided with a single 1200A circuit breaker. A 16 Circuit panel with a 100A main circuit breaker is provided for the enclosure lighting, GFCI type receptacles, and generator accessories. The generator was installed by the Town’s Civil Defense and connects to a pad mounted automatic transfer switch adjacent to the generator. This automatic transfer switch appears to feed a manual transfer switch for distribution panel D1. Distribution panel D1 feeds panels in the 1995 addition as well as the Boiler Room and Cafeteria Panel. The generator also appears to feed a transfer switch for the fire pump. The generator appears to be in good condition.

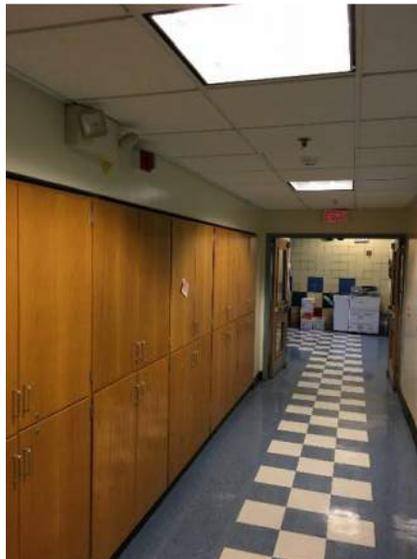
**Corridor with Emergency Battery Unit**

The emergency lighting system generally consists of emergency battery units and battery backup exit signs. Exit signs are LED. There are no exterior emergency lighting fixtures which is an NEC/IBC code violation. The emergency lighting appears to provide adequate coverage and appears to be in good condition with where the majority of the units were installed during the 1995 building project, they should be considered to be replaced under any new construction project.

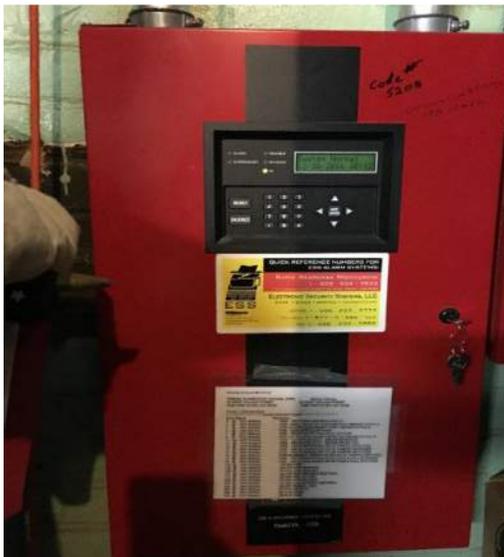
**Fire Alarm Control Panel**

The fire alarm system control panel is located behind the door of the upper level of the Boiler Room. The panel is a Silent Knight SK-5208 20 conventional type panel and appears to have been installed in the last 5-7 years and appears to be in good condition. The system is not a voice system. The system is central station connected via digital communicator.

According to the 2015, International Building Code, 907.2.3, in a Group E occupancy of over 50 occupants, a voice alarm communication system is required.

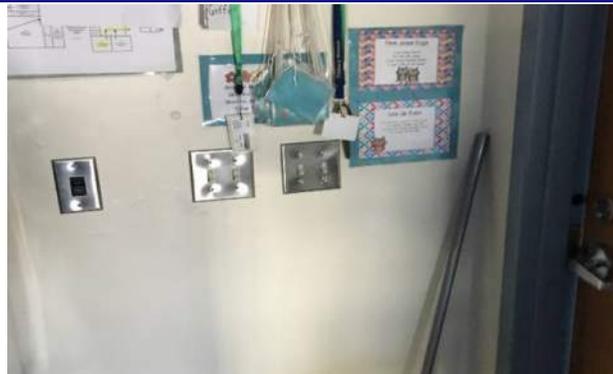
**Classroom Switching**

Lighting is controlled primarily via local switches with occupancy sensors in a few of the rooms.

The lighting controls do not meet the requirements of the latest edition of the International Energy Conservation Code for automatic controls and daylight harvesting.

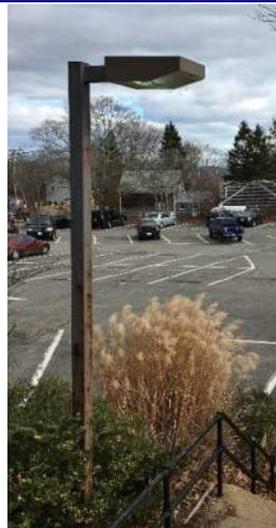
**Pole Lighting Fixture**

Site lighting consists of building mounted flood lighting. Exterior doors have wall mounted sconces in fair condition. Exterior doors with canopies have recessed compact HID fixtures. There is a pole light at the stair to the main parking lot which is in poor condition.

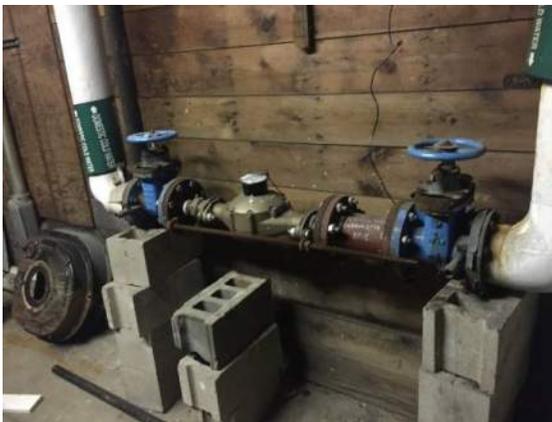
**WATER METER**

The water meter assembly is two four-inch OS&Y valves, spool connection, two-inch Neptune water meter. The service is not provided with any backflow prevention or a full-size by-pass.

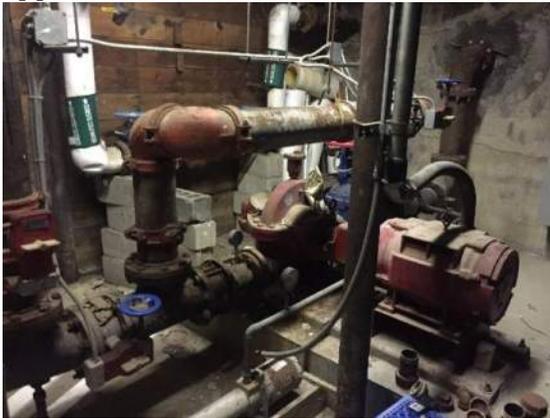
**FIRE PUMP**

The building fire pump is a base mounted split case centrifugal type pump. The pump is 50 HP. The design and delivery gallons per minute and discharge pressure was not determined. The system was provided with a pump controller panel. It appears the transfer switch was added to the system at a later date.

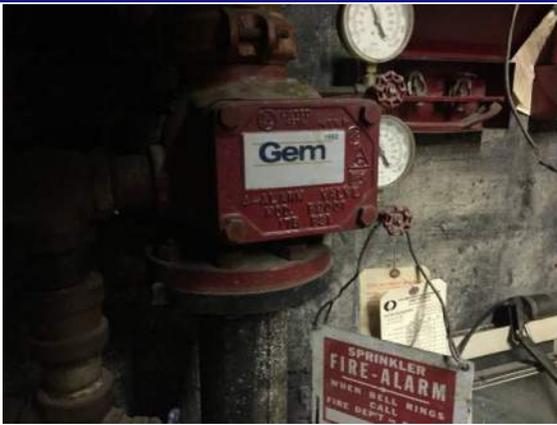
The building is fully sprinkled. There is a Gem four-inch alarm check valve provided on the discharge side of the fire pump. The building is protected by number of sprinkler zones which are addressed with a supervised switch (sprinkler zone). Some areas of the building are provided with sprinkler coverage above and below the hung ceilings.

**ALARM CHECK VALVE**

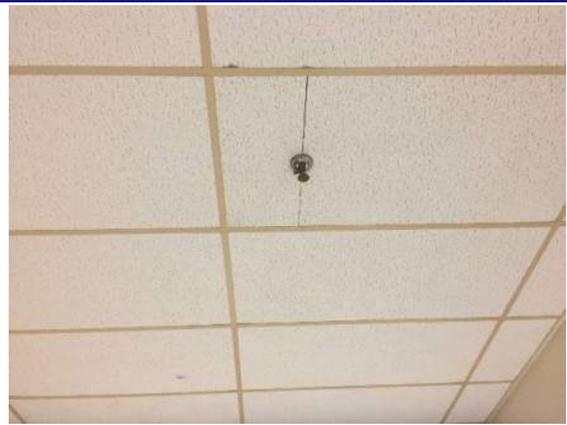
**SPRINKLER HEAD**

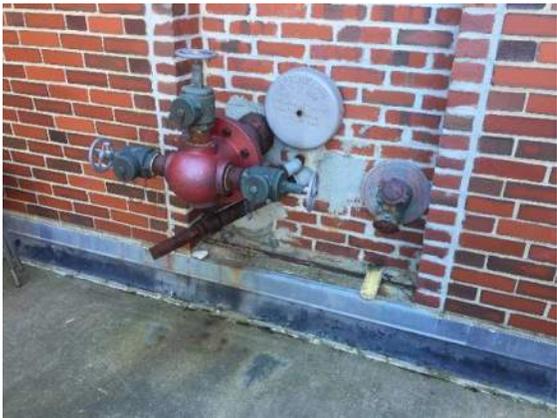
**FIRE DEPARTMENT CONNECTION  
& ALARM BELL**

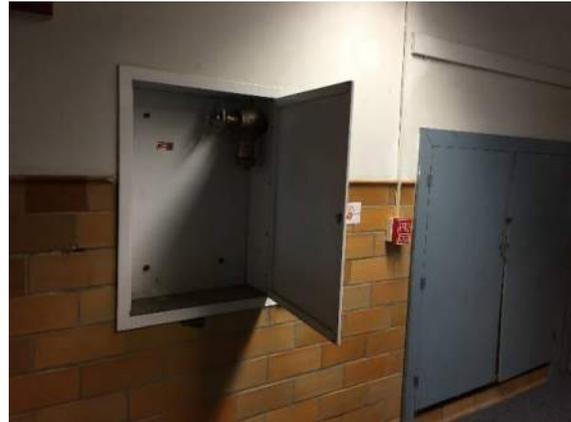
There are number of fire valve cabinets, the cabinets have the hoses removed. The valves are 2 ½" X 1 ½" reducer.

**FIRE HOSE CABINET**
